SUBJECT: **FIREFIGHTER INJURY REPORT - GREENSHEET
ADAMS STRUCTURE FIRE LESSONS LEARNED**

FIREFIGHTER INJURY ADAMS STRUCTURE FIRE

JULY 24, 2007

ADAMS STRUCTURE FIRE FIREFIGHTER INJURY REPORT

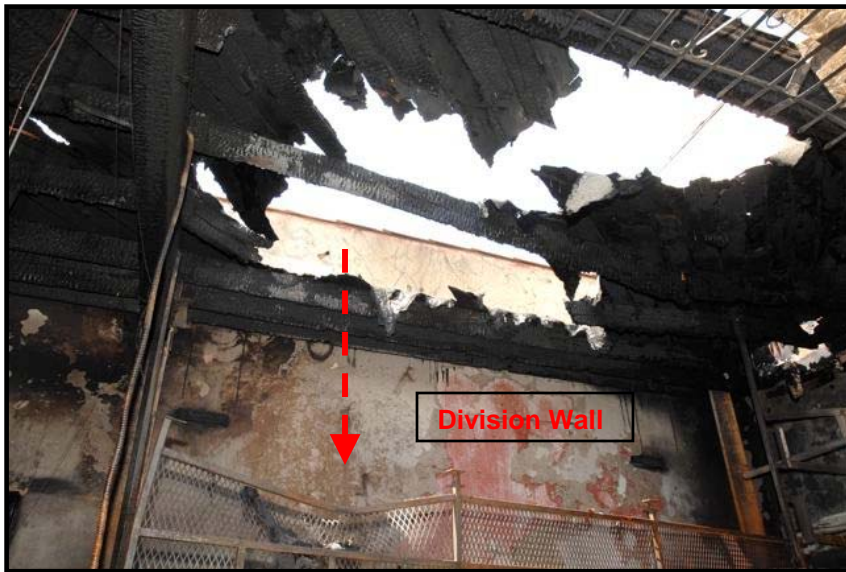
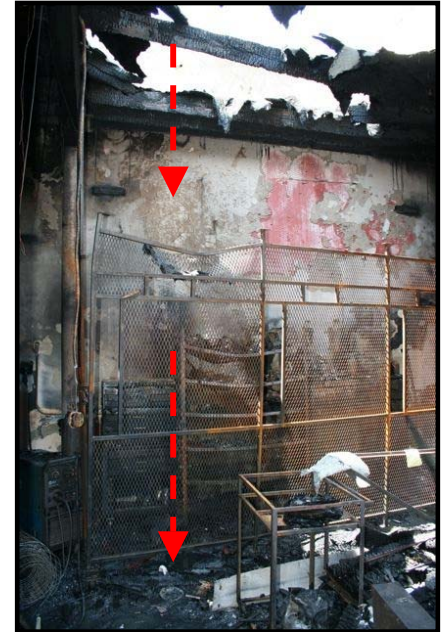
The injured member assigned to Truck 26 stepped onto a portion of roof weakened by fire and fell approximately 5', 4" striking a metal room divider and continued to fall approximately 7', 10" to the floor of the structure. The room measured approximately 30' x 60'.

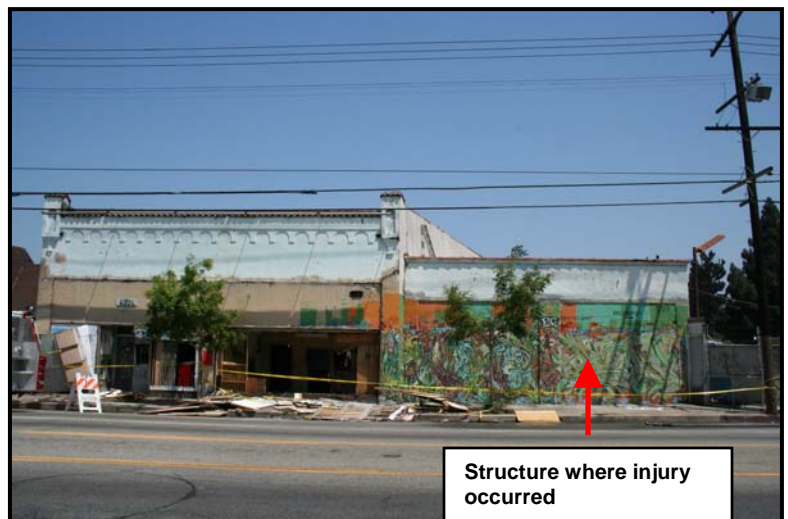
The structure was two single story commercial occupancies combined together to total approximately 125' x 150' in size, the occupancy was divided into several work/storage areas. It was constructed of a wood frame with stucco exterior siding, conventional flat roof. The area involved in the fire was being used as a welding shop to create metal sculptures.

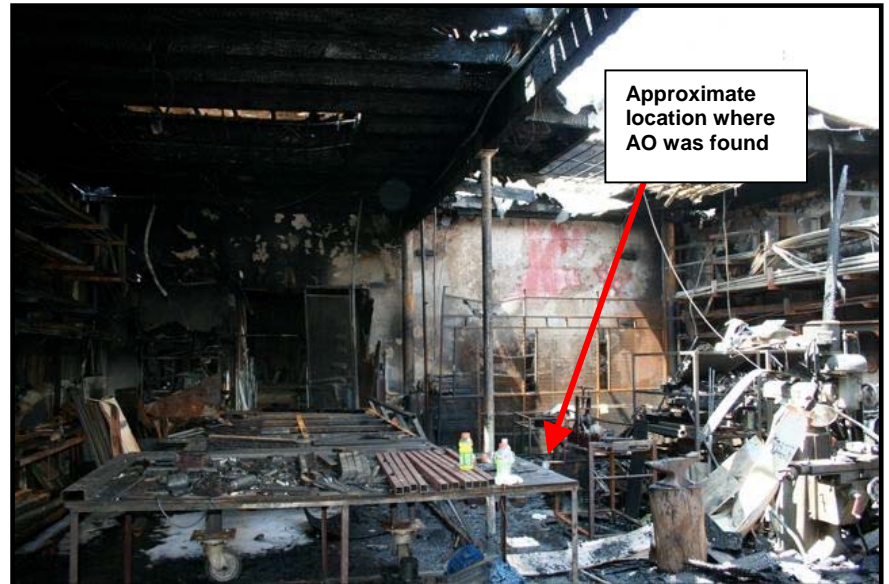
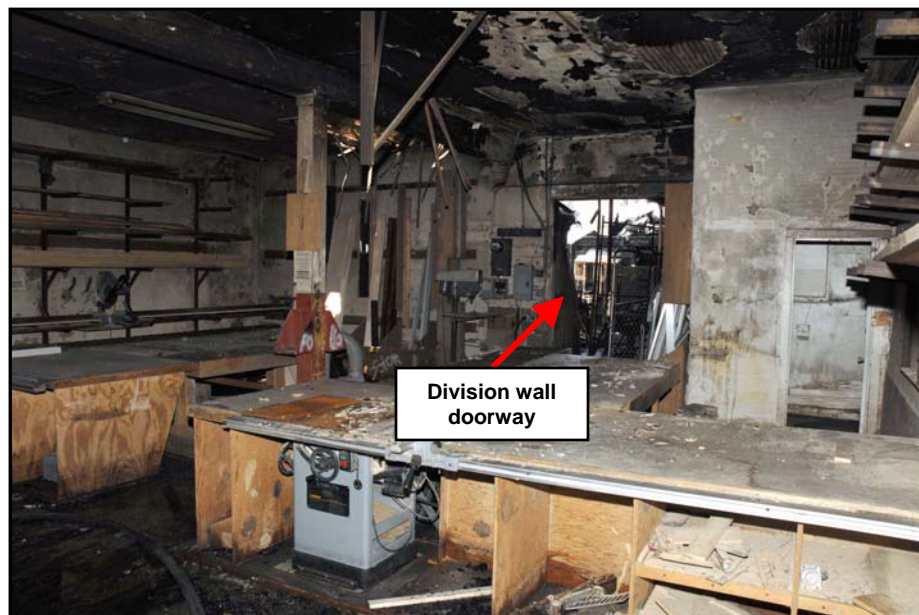
View of structure from "D" fire attack entry

Engine companies 68, 34, and 26 were assigned interior fire attack and upon hearing the announcement of the AO through the roof initiated a search of the structure finding and rescuing the missing AO. Engine 26 used two thermal imaging cameras during the search. The AO was carried out of the structure by various personnel, assessed and treated by Rescue 68 personnel. The AO was semi-conscious and able to talk². Witnesses stated that during the rescue, heavy interior smoke was present with near zero visibility. The ceiling and roof members sustained heavy fire damage.
