SUBJECT: **FIREFIGHTER INJURY REPORT - GREENSHEET
ADAMS STRUCTURE FIRE LESSONS LEARNED**

FIREFIGHTER INJURY ADAMS STRUCTURE FIRE

JULY 24, 2007

ADAMS STRUCTURE FIRE FIREFIGHTER INJURY REPORT

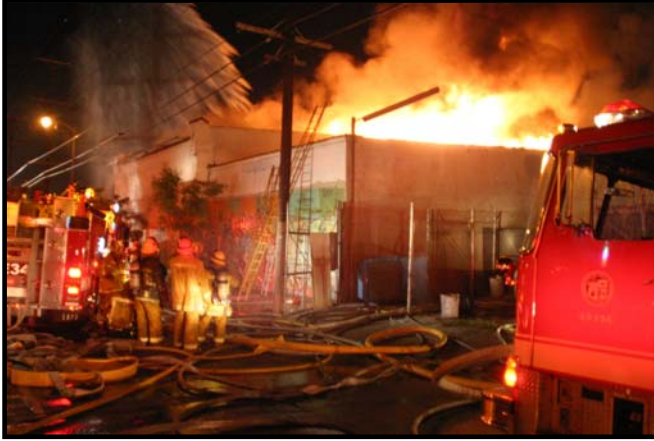
On July 24, 2007, at 2020 hours, a first alarm assignment consisting of Engine 68, Engine 34, Rescue 834, Task Force 26, Task Force 61, Rescue 61, EMS 18 and Battalion 18 were dispatched to a reported structure fire at 5111 W. Adams Boulevard. Rescue 68 and Rescue 868 were added to the incident after the initial dispatch.

EMS 18 arrived first on scene at 2022 hours and made the initial size up of a single story commercial with heavy smoke and fire through the roof. Engine 68, second to arrive on scene, established a supply line and performed forcible entry through a chainlink gate, wood door and scissors gate on the "D" side of the structure. Engine 68 along with Rescue 868 personnel then initiated fire attack operations utilizing a 1 3/4" hose line.

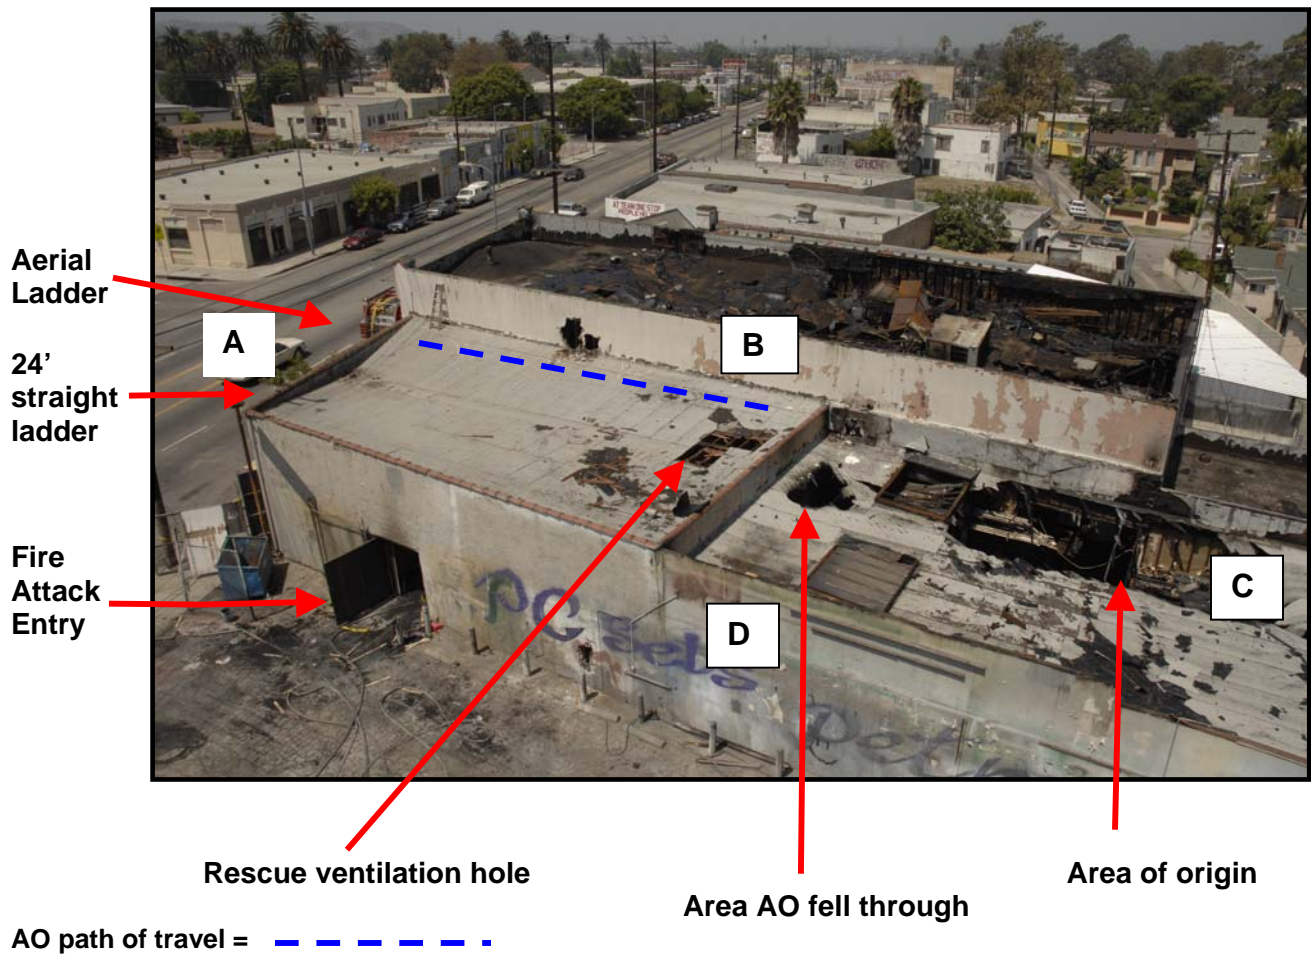
The AO did not wait for the ventilation team and was seen traveling rapidly on the "B" side with no sounding tool(s). On the roof the Inside firefighter shouted for the AO to stop and come back the other way, but the AO did not stop or acknowledge the shouting. The AO was seen looking at the area of the roof involved with fire prior to falling through the roof.
